Carroll Elementary

General comments, campus capacity, and student demographics

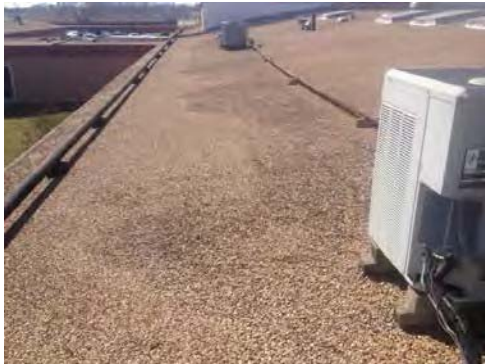
Roofs

- The 1991 addition roofs are in fair condition but beyond the average useful life cycle. The original roof areas are built-up gravel and have several areas that are exposed surface. Several areas inside the buildings showed small leaks that may be past and present.

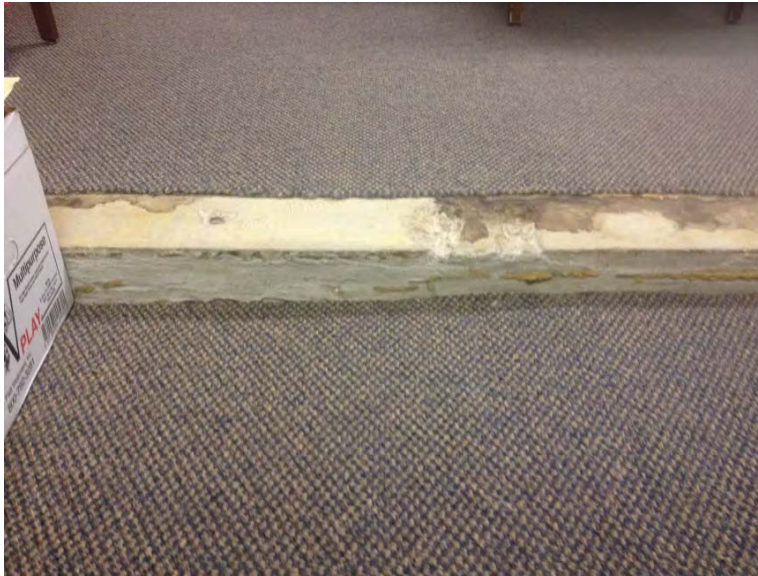
Flooring

- The flooring in the original areas of Carroll Elementary is in poor condition. The carpet is stained and needs replacement in several areas. There are several areas where the foundation is uneven and causes trip hazards. Transition from hallway to classroom is also uneven.

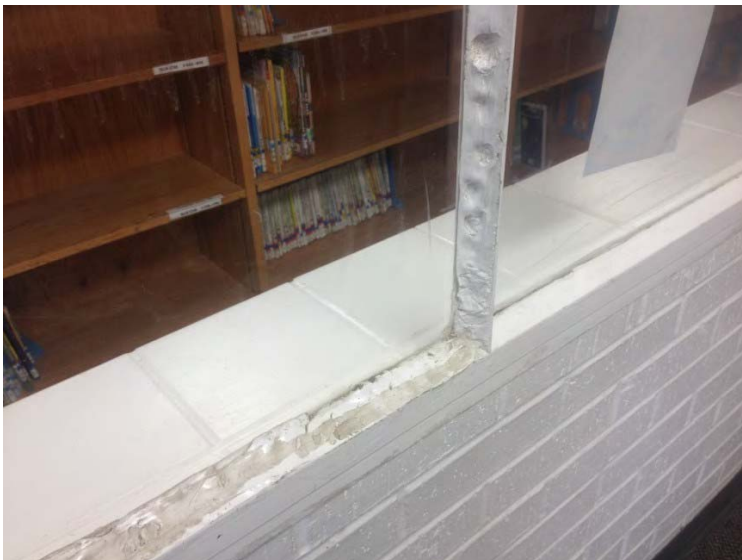
Interior Doors, Cabinets, Ceilings and Walls

- Interior finishes are in fair condition. Doors remain sturdy. Ceilings and walls in the 1991 addition are in good condition. The interior classroom walls are made up mostly of windows, which were once exterior windows. They are single pane glass, which can get noisy. The glazing around the windows is cracking and chipping.

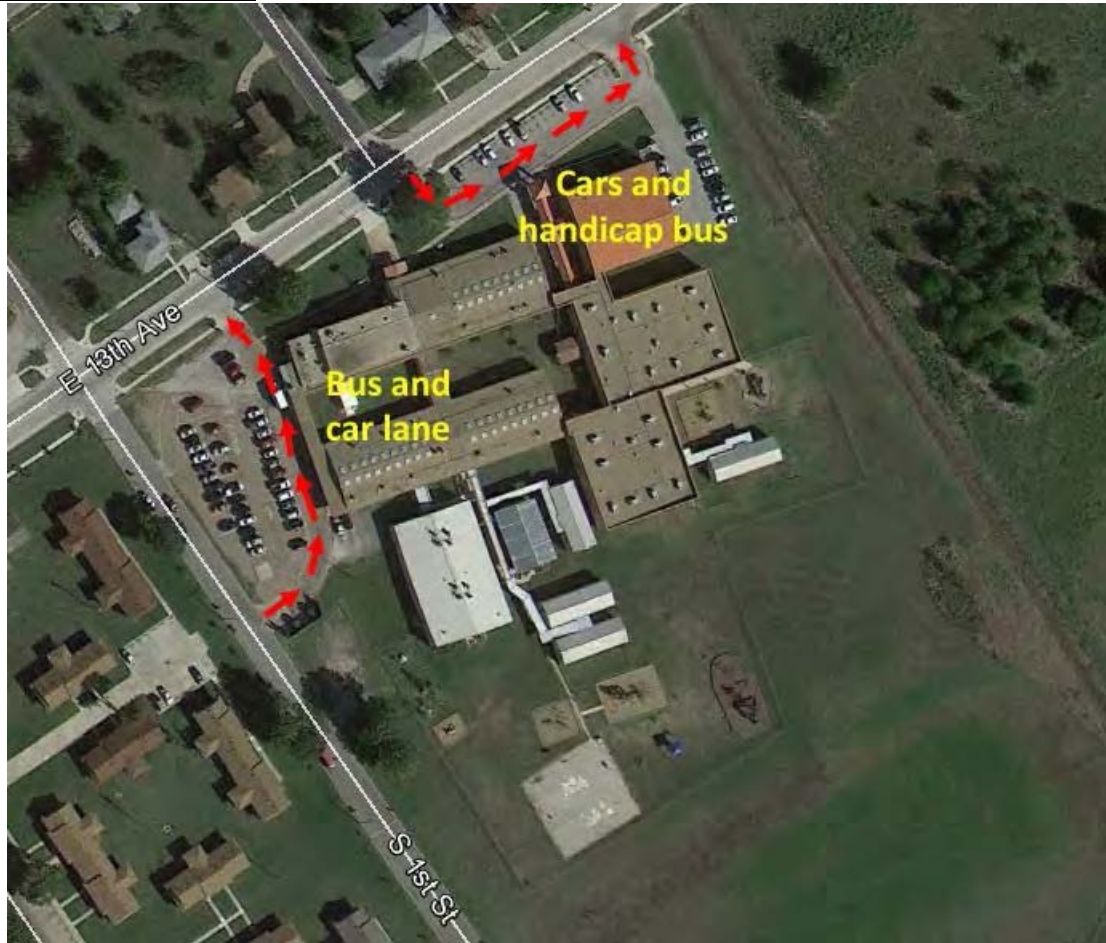
Student Loading Areas

The bus and car lane on the west side can only allow 14 vehicles to stack off of the right-of-way. The car and handicap lane on the north side only allow for 12 vehicles to stack off of the right-of-way. Current layout of the parking/drives is outdated for the student/teacher population. Several areas between parking and the buildings require students and teachers to cross bus and parent traffic with no designated walkways.

- At the pickup lane on the west side of the buildings that separates the teacher parking from the building, there are times with only 2 buses but there are 200-300 students on the sidewalks. Students, parents, and teachers cross the lane to get to their vehicles and to the neighborhood.
- There is available space on the southwest side of the buildings that could serve as an independent pick-up and drop-off lane. This would likely alleviate a large amount of the flow that is causing many of the issues.
