Collins Middle School

General comments, campus capacity, and student demographics:

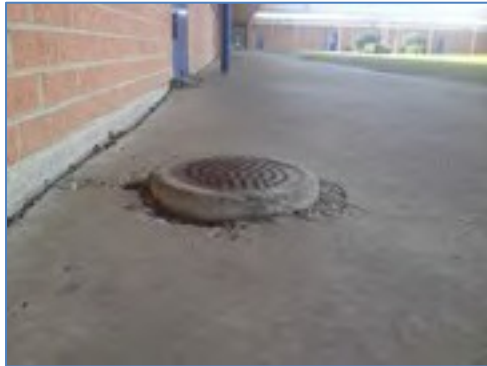
- Poorly placed drain in sidewalk of 100 building.

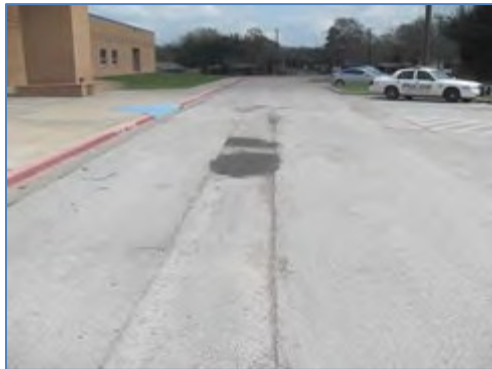
- Recommend seal coating all asphalt parking surfaces within the next 2 years.
- Poor asphalt spot at south entry drive.

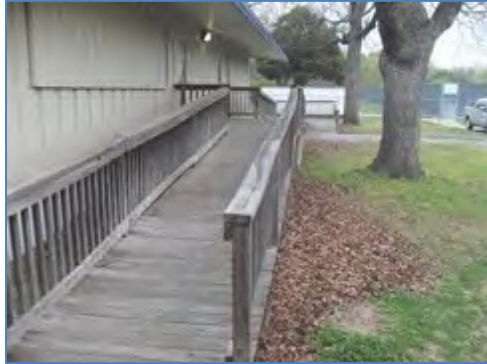
- Non-compliant thresholds at 100 building and Shop building.
- Shop building doors have knobs in lieu of lever hardware.
- Sink pipes and drains are not insulated in boy's restrooms in 100 and 400 buildings.
- Lever hardware needed on ADA sink faucet in boy's restroom in 400 building.
- Non-compliant handrails at portable building ramps.

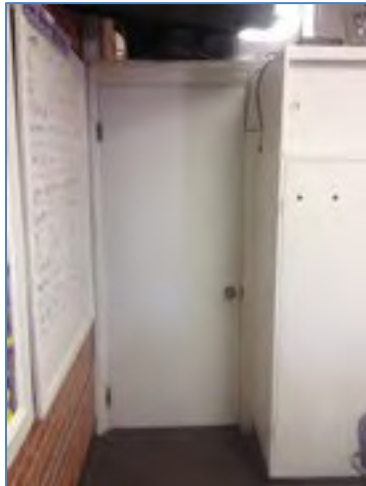
- Approximately 3" of wheelchair maneuvering clearance at pull side of door in 100 building, 18" minimum needed.

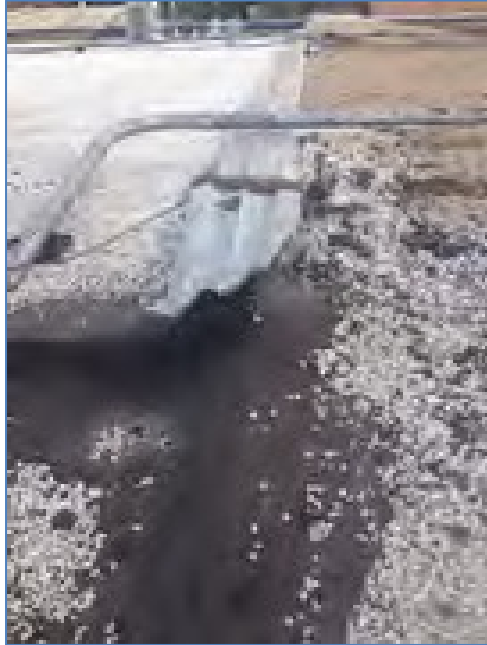
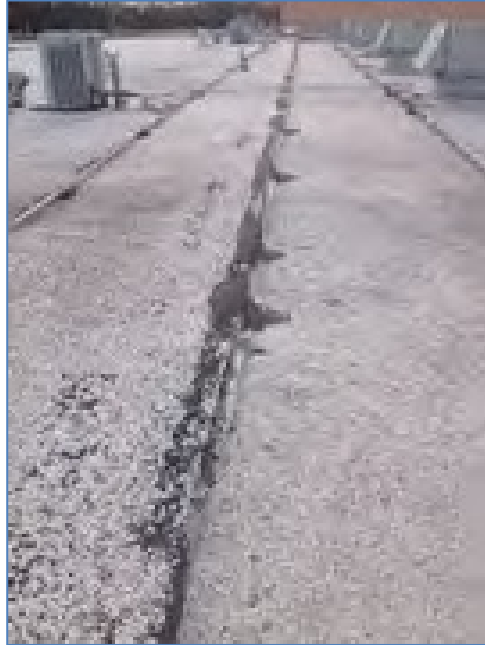
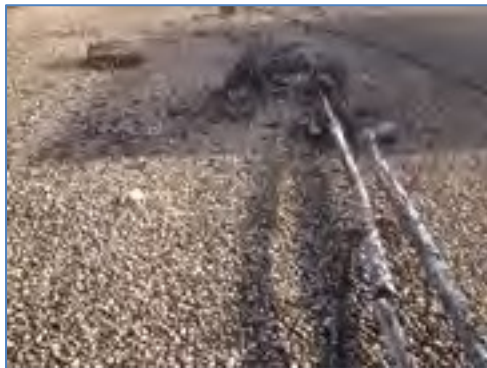
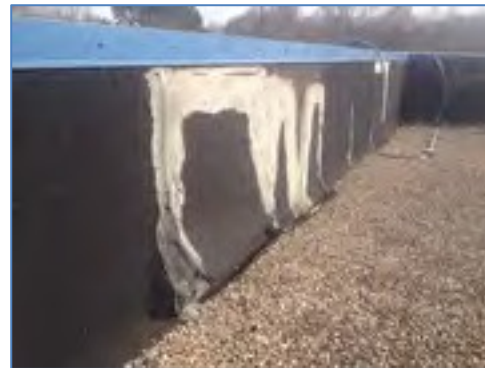
- Roofs on 100 building, weight room, and Shop building are standing seam metal and are in good condition. All other roofs are built-up gravel. The roofs on the Girls gym/Café/500 building, Band Hall, and 600 building are in good condition. The roofs on the 200, 300, 400, and Boys gym buildings are in fair-to-poor condition and are 20+ years old; these roofs have reached the end of their expected life cycle and replacement should be budgeted for in the next five years.

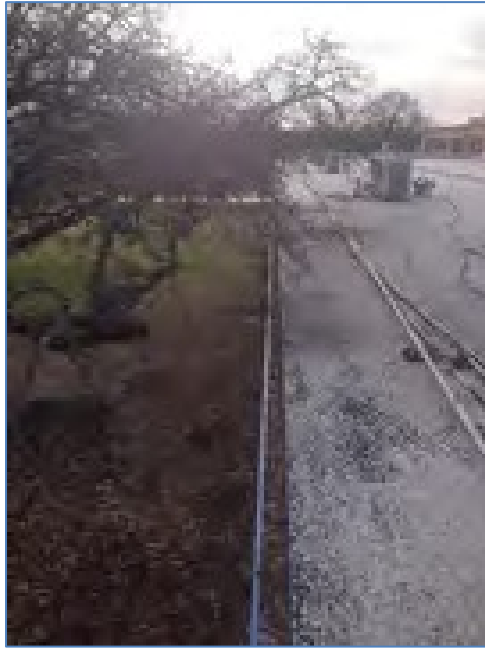
- Trees growing over and against roof lines should be trimmed at least 6 feet from the building.

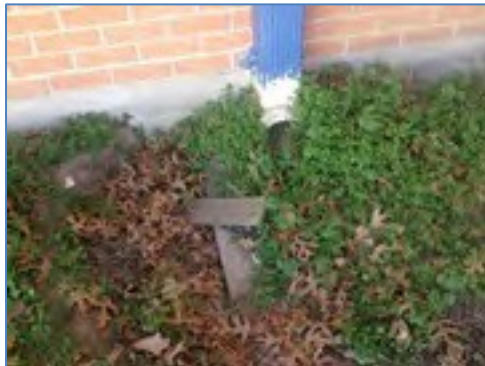
- Poorly placed splash blocks at 300 building.

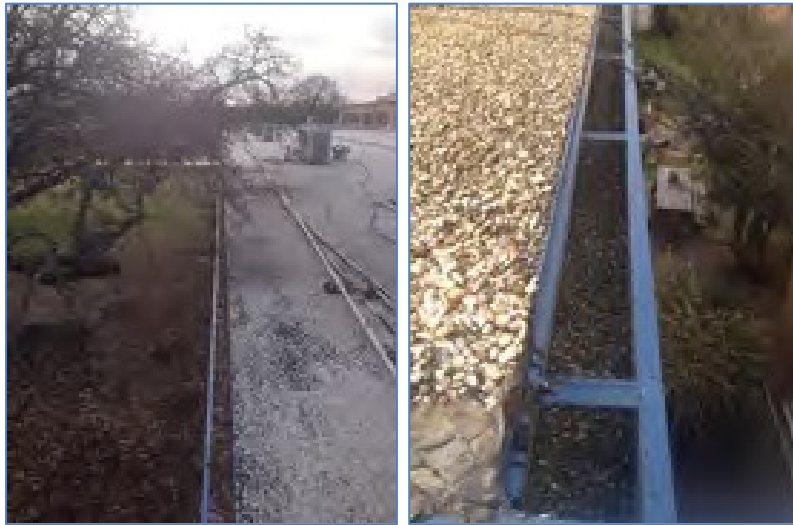
- Gutters need cleaning at several building locations.

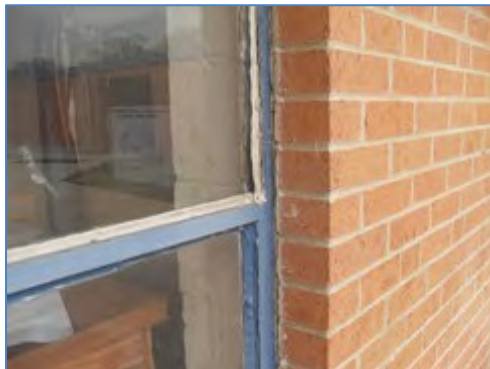
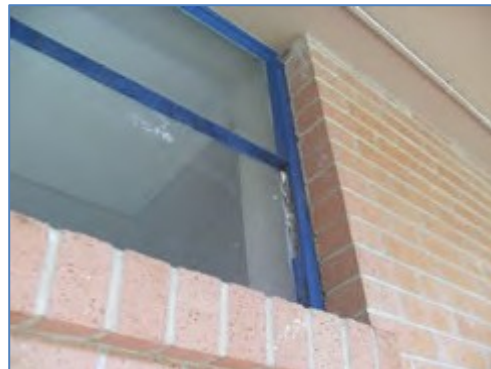
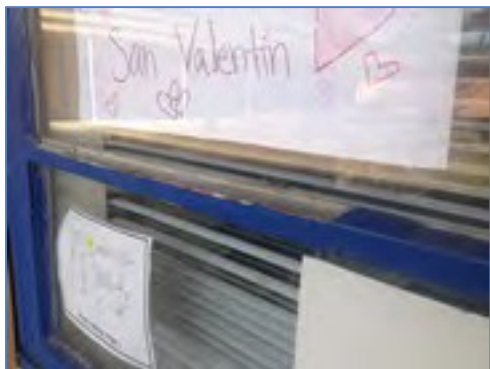
- Windows in all 100, 200, 300, 400, Shop, and Boys gym buildings are inefficient single pane and caulk and glaze is failing. Building expansion joint caulk is failing or beginning to fail at 100, 200, and Boys gym buildings.
- Poor glazing and caulk, and window frame wear, at 100, 300/400, and Boys gym buildings.

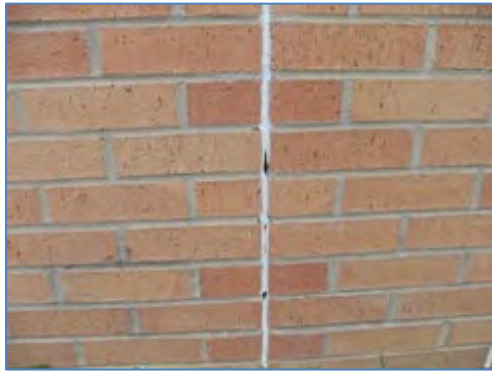
- Failing caulk in joint seams at Boys gym.

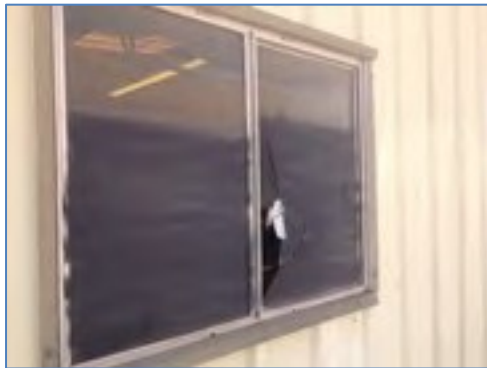
- Broken window at Shop building.

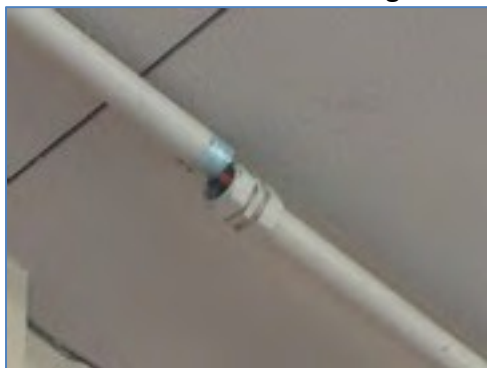
- In many classrooms extension cords are being used for permanent power connections.
- Broken conduit at 100 building.

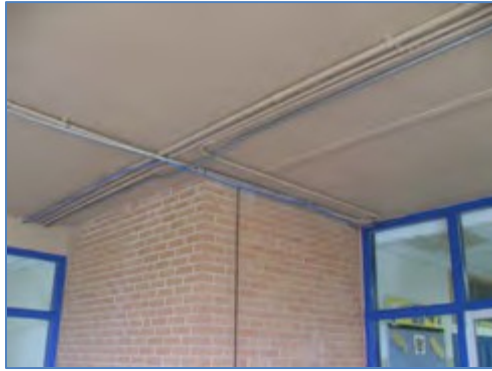
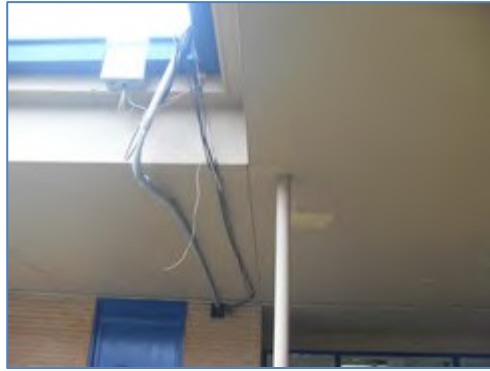
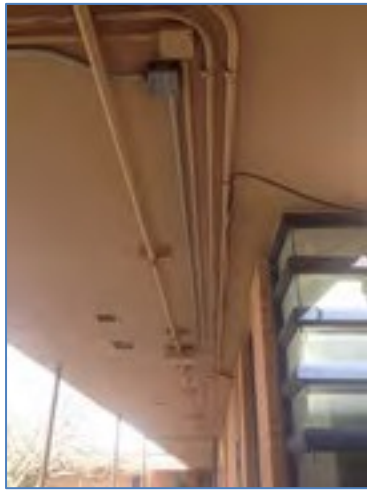
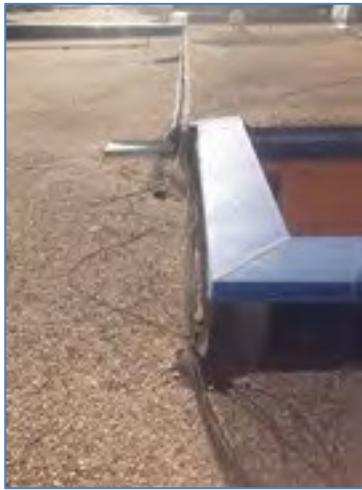
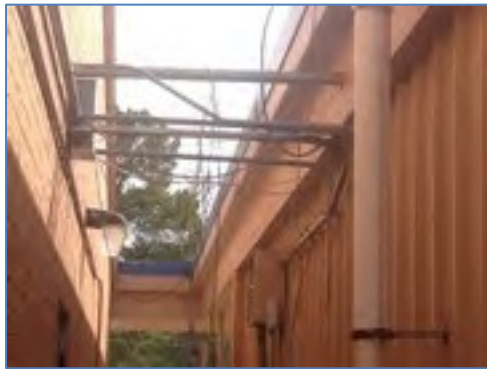
- Exposed exterior data cable and wiring is common around campus and on rooftops. Exposed cable and wiring should be placed inside conduit for better protection.

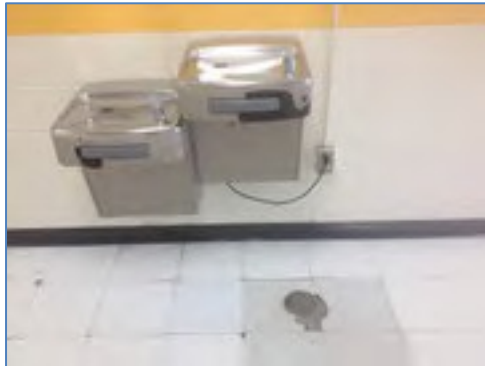
- Surface damage on drinking fountains located near Girls gym.

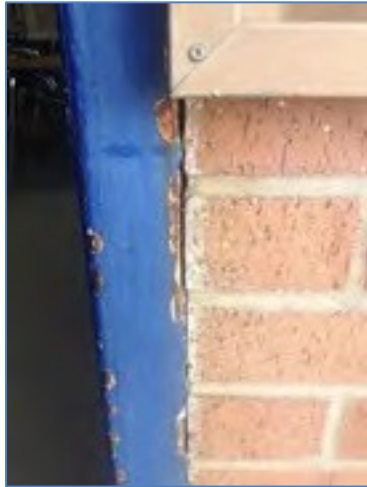
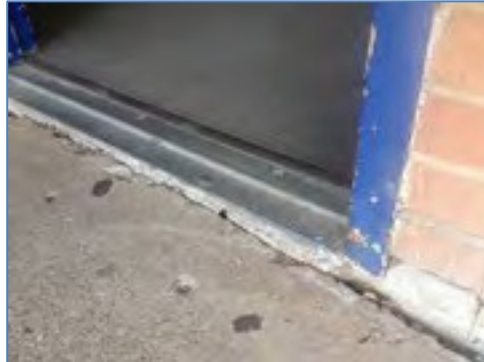
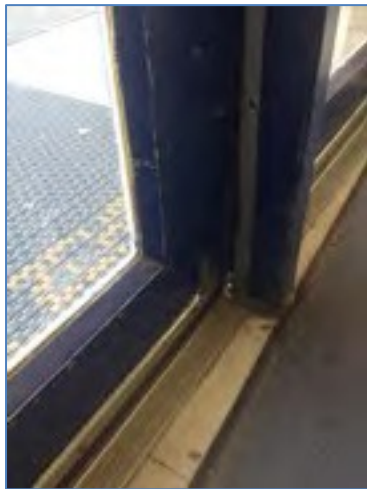
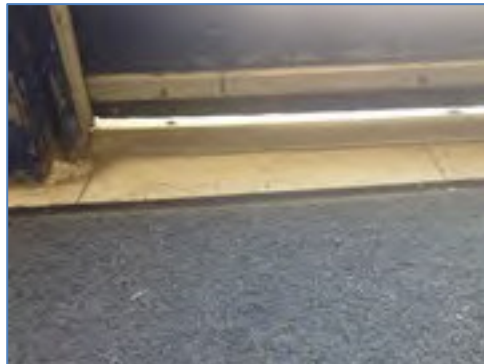
- Most exterior painted finishes at all buildings except 600 and Band Hall buildings are in fair-to-poor condition and are in need of repair and repainting.
- Door frame wear at 100 and 400 buildings.

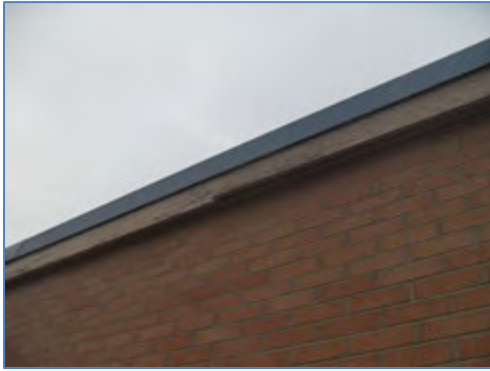
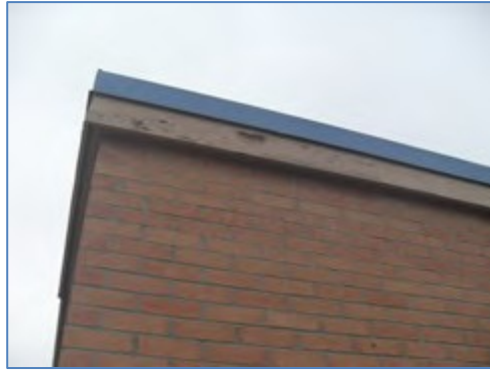
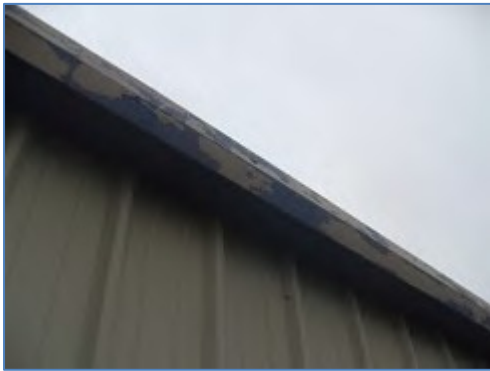
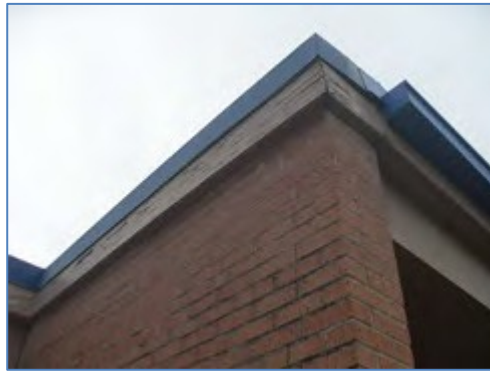
- Poor, flaking paint on fascia trim of Boys gym locker room, weight room, and 300/400 building.

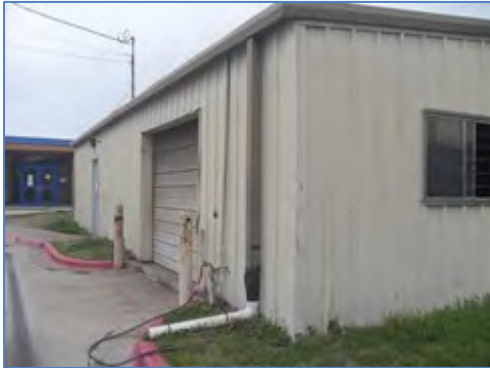
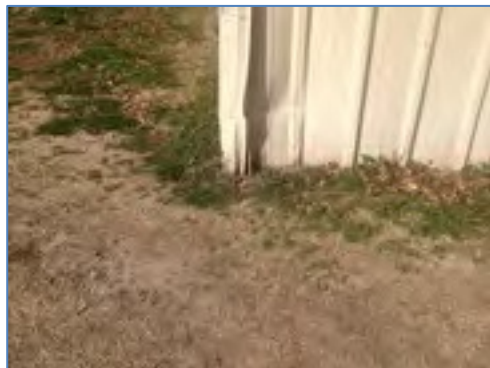
- Metal damage and poor paint on Shop building.

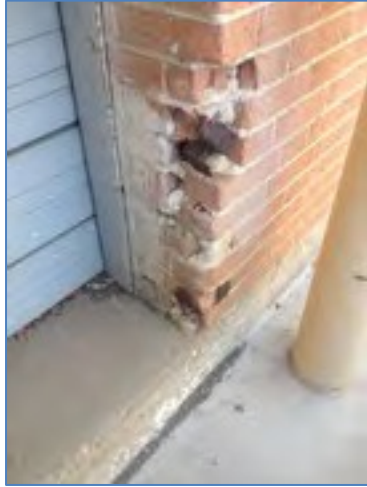
- Damaged brick outside of art room.

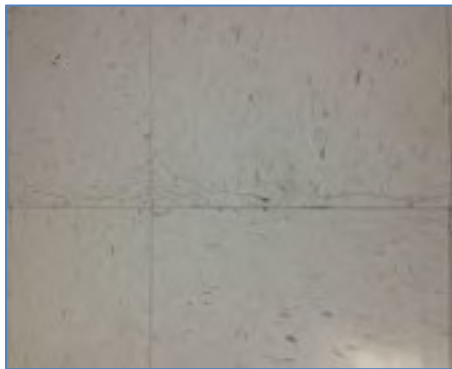
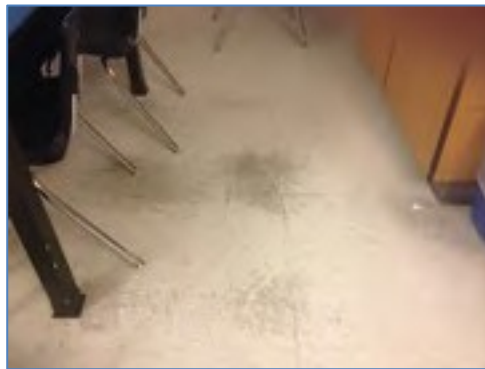
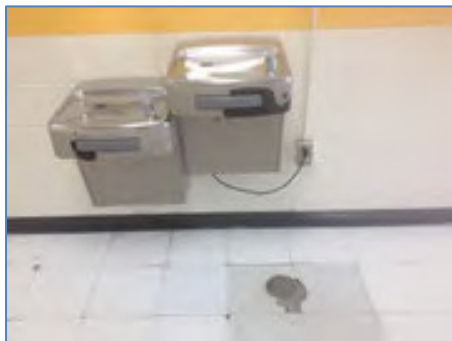
- Carpeting in all buildings is in fair condition; carpet should be replaced within the next 5 years. When the existing carpet is replaced, it should be replaced with carpet tiles to allow small stained or damaged areas to be replaced without replacing entire areas.
- VCT in 100, 200, 300, and 500 buildings is in fair condition and should be budgeted to be replaced in the next 5 years.
- VCT cracks in 300 building, worn VCT in 500 building, and damaged VCT near Girls gym.

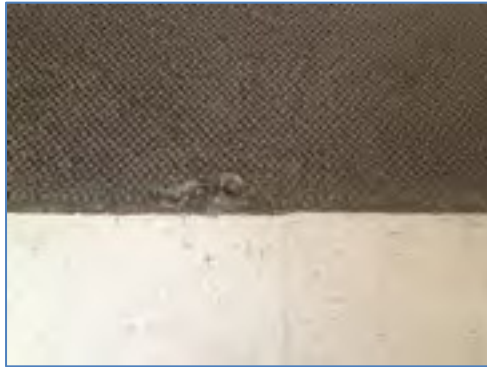
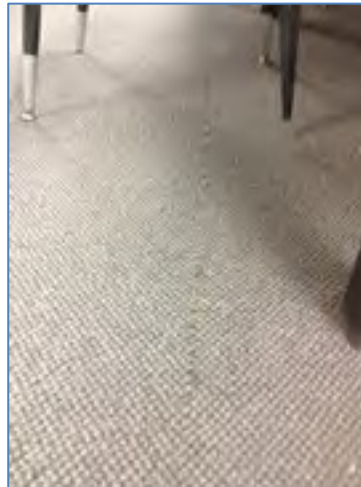
- Carpet seam damage in rooms 201-2 and 400 building.

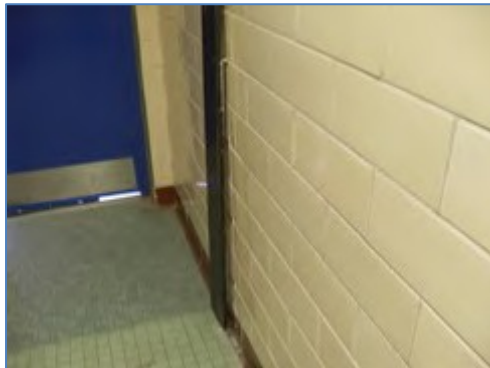
- Interior painted surfaces are in fair-to-poor condition in the 100, 200, 300, 400, and Boys gym buildings; interior surfaces should be repainted in the next 3 years.
- 2'x4' ceiling tile in the 100, 200, 300, 400 and Boys gym buildings is in fair-to-poor condition and should be replaced within the next 5 years.
- Board patch pulling away from wall in boys restroom of 100 building.

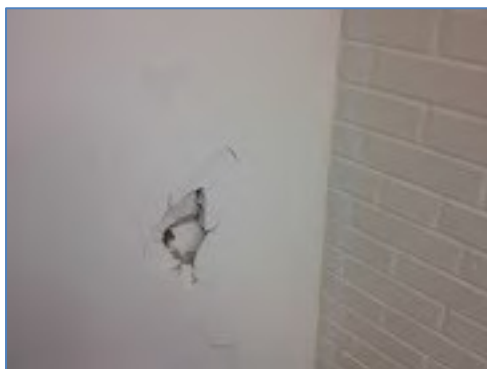
- Hole in wall in rooms 201-2.

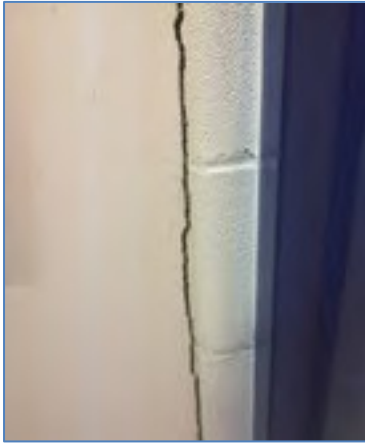
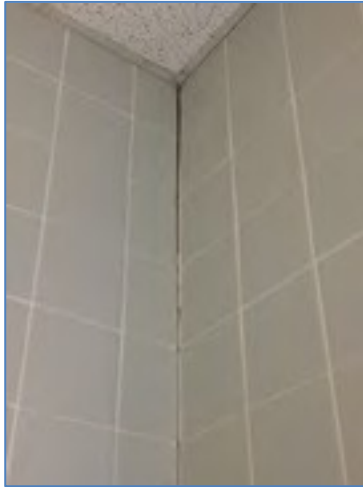
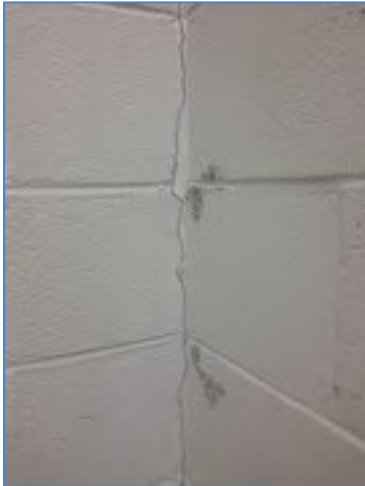
- Wall cracks in 300 building, 400 building restroom, and Girls gym.

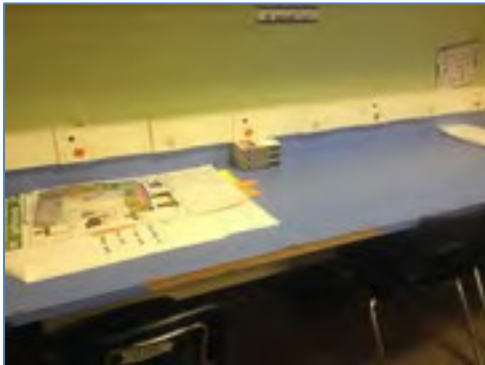
- Damaged counter edge in 100 building classroom.

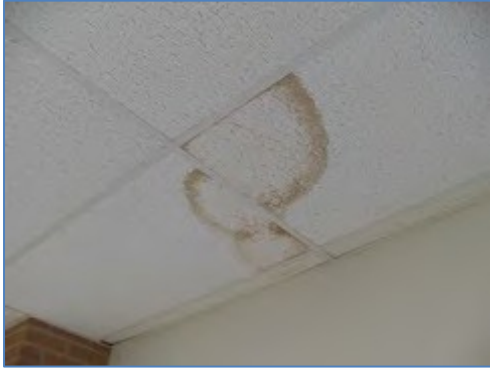
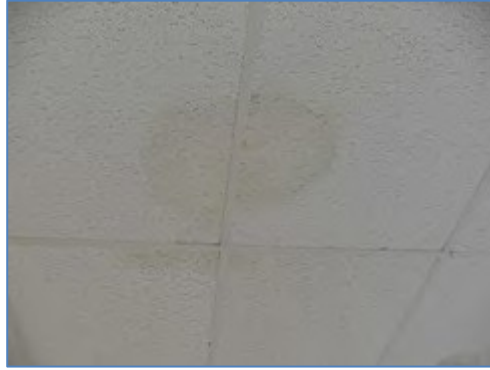
- Stained ceiling tiles in main lobby by office area.

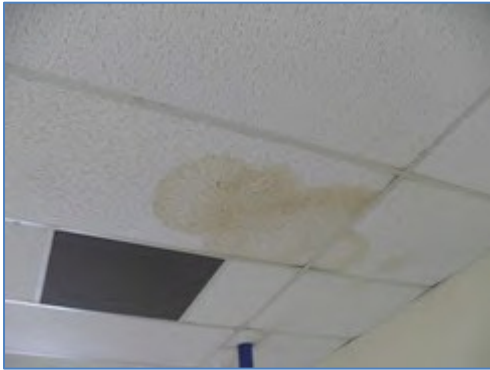
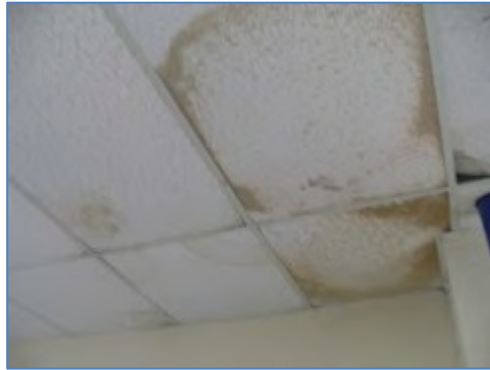
- Stained and bowed ceiling tiles in hallway between Boys gym and 400 building.

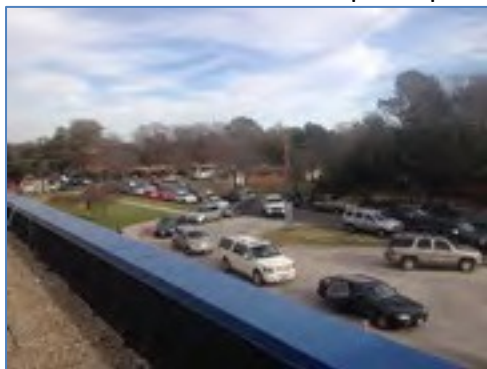
- Canopies should be provided at all student loading areas to provide protection from weather.
- Parent loading for drop-off and pick-up on south side of campus backs up, especially during afternoon pick-up. Afternoon parent and bus pick-up traffic takes approximately 10-15 minutes to disperse. Some parents circumvent the pick-up lines by parking on the streets, and crossing parent and bus lanes to pick-up their children and walk them back; this creates additional safety hazards.
- Parent traffic at afternoon pick-up.
