Navarro Elementary

General comments, campus capacity, and student demographics:

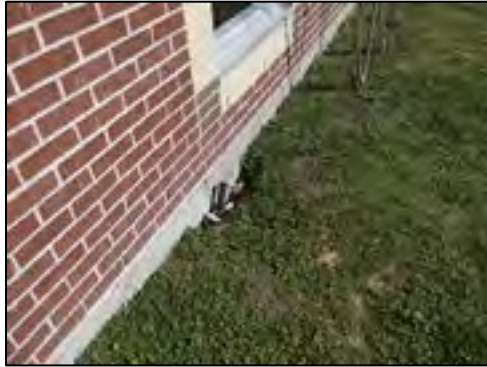
- Low area next to building can trap water next to foundation.

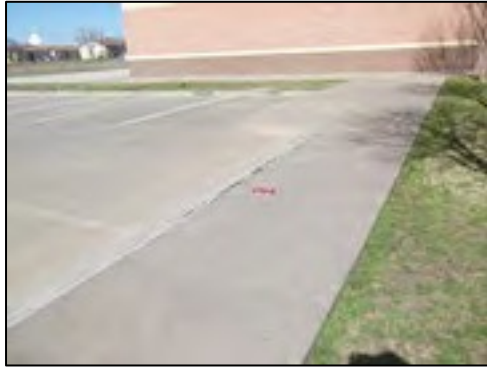
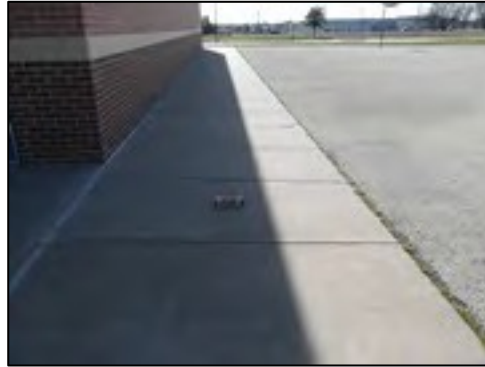
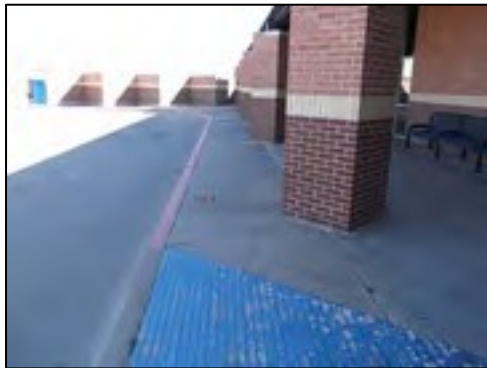
- Sidewalk cross-slope varies from about 5% to 7% in several areas; 2% maximum needed.

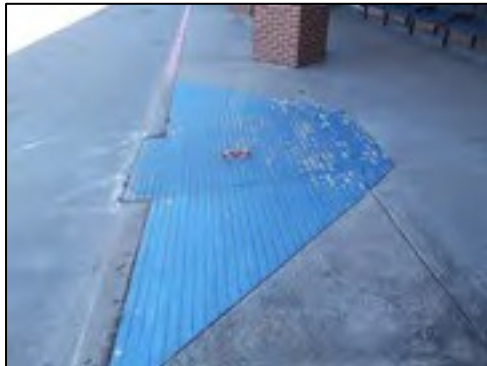
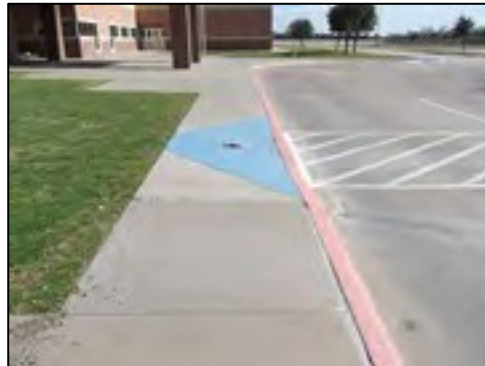
- Curb ramp slope varies from about 10.5% to 12.5% in two locations; 8.3% maximum needed.

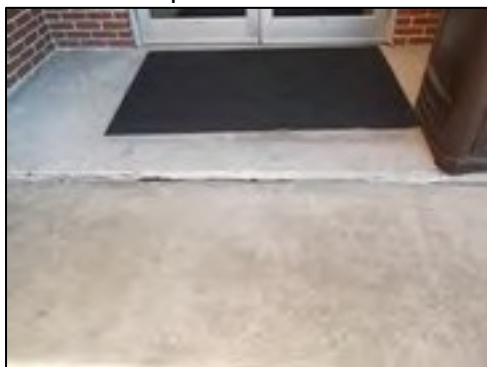
- One inch drop in sidewalk between walk path and door landing.

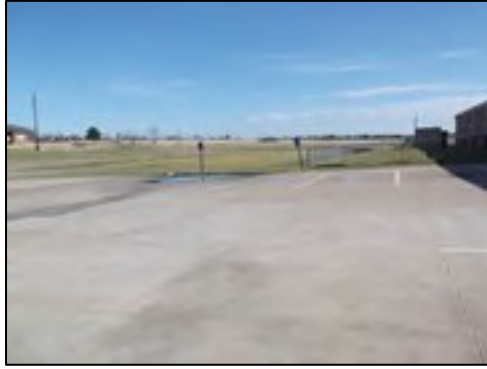
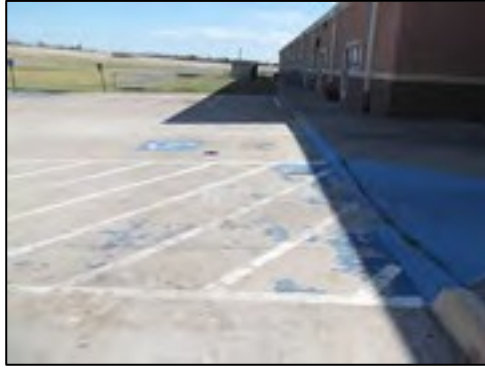
- Noncompliant parking spaces at east cafeteria parking.

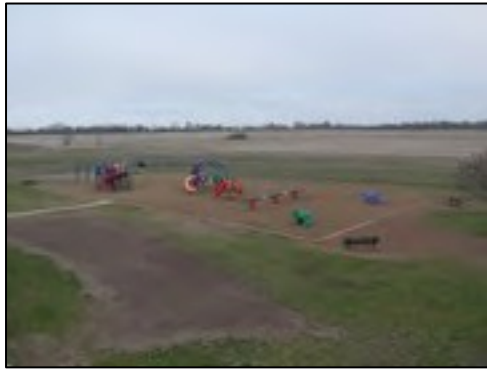
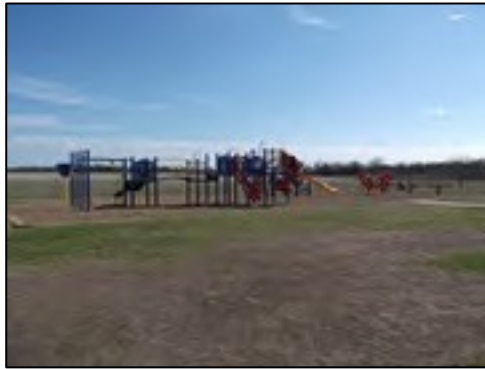
- No ADA access provided to south playground equipment.

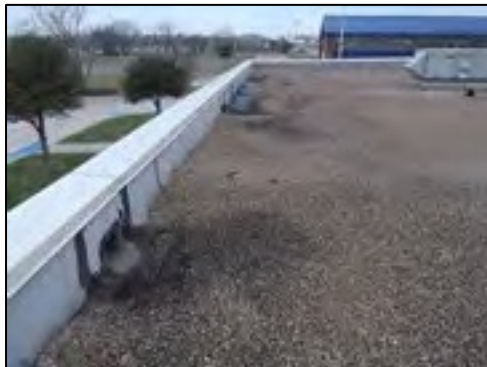
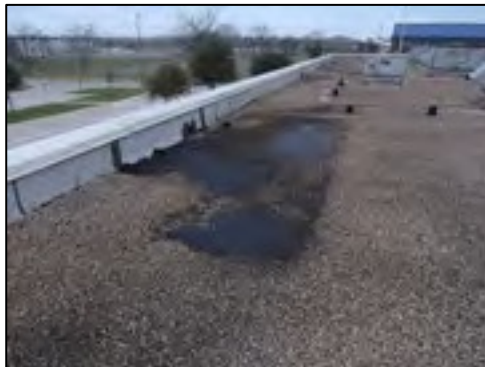
- The roof is primarily built-up gravel (in fair condition) except for the entry porch which is standing seam metal (in good condition); the roof is 15 years old. The built-up gravel roof is approaching the end of its expected life cycle and replacement should be budgeted for in the next five years.
- Bare spots at several roof locations.

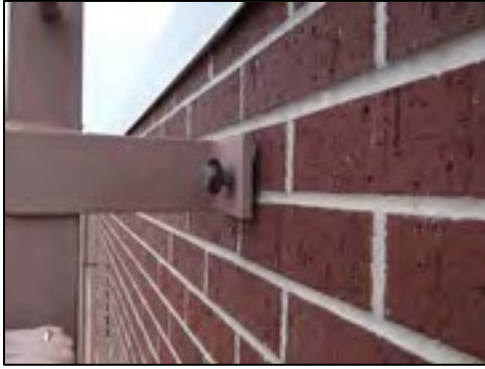
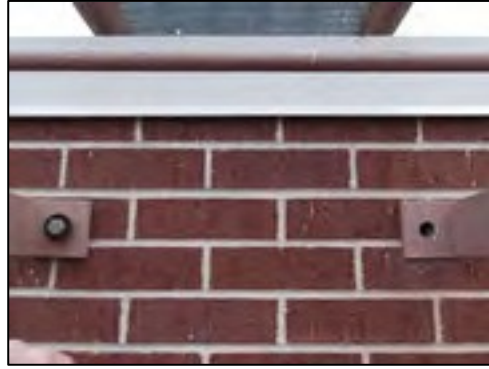
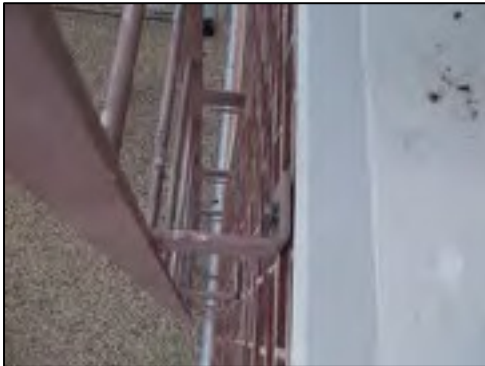
- Loose and missing bolts on roof ladders.

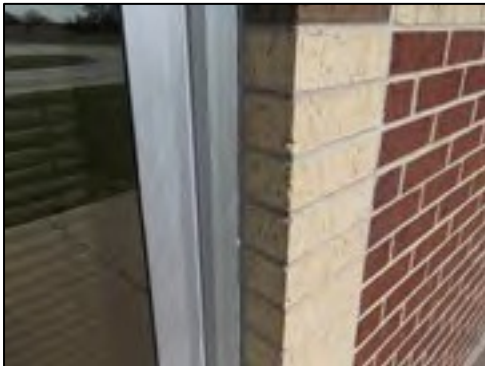
- Building expansion joint caulk is failing or beginning to fail.
- Window caulk is failing.

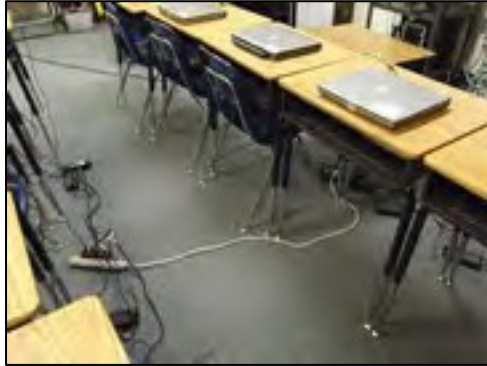
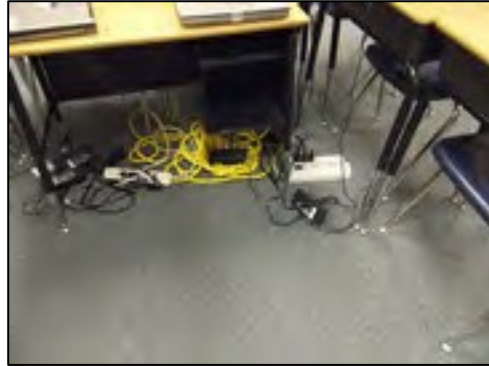
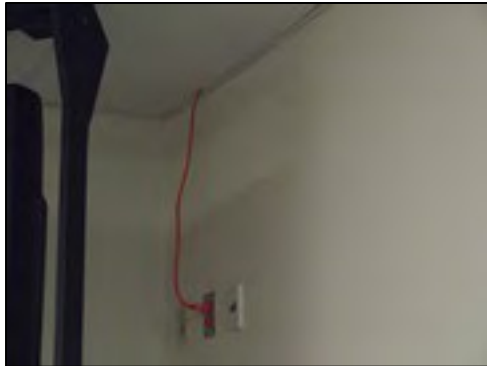
- In many classrooms extension cords are being used for permanent power connections and are also being daisy-chained.

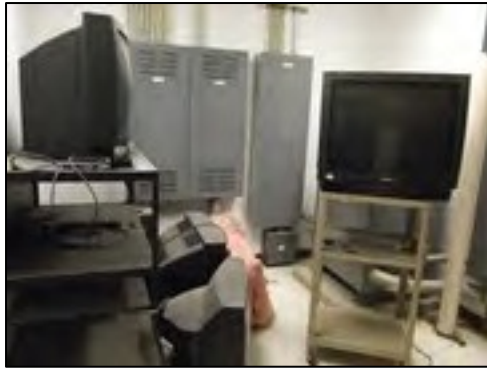
- Electrical panels are blocked; electrical rooms should not be used for storage.

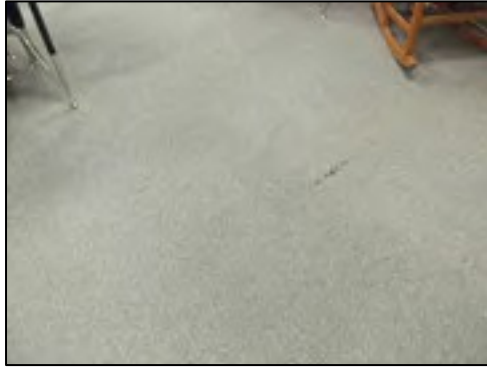
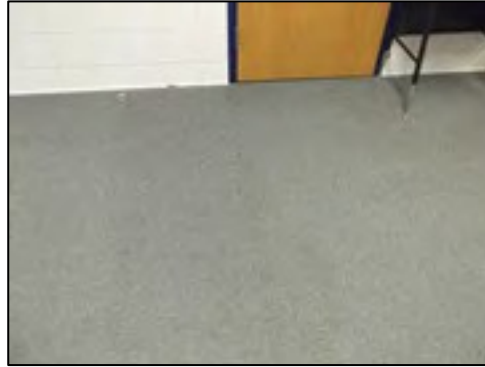
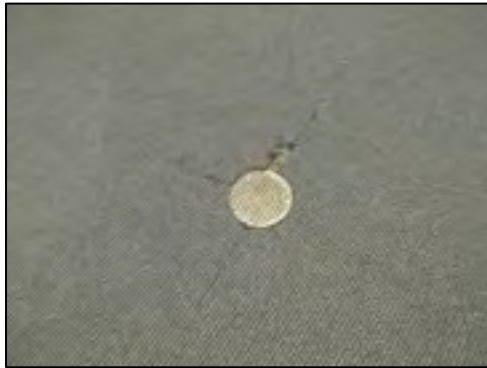
- Carpeting is in fair condition with rips and seams visible in several locations; carpet should be replaced within the next 5 years. When the existing carpet is replaced, it should be replaced with carpet tiles to allow small stained or damaged areas to be replaced without replacing entire areas.

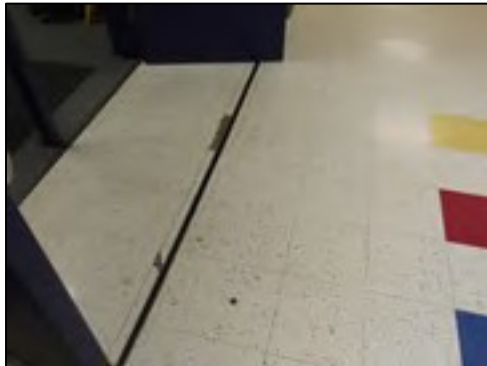
- VCT cracking along expansion joint between C wing and main building.

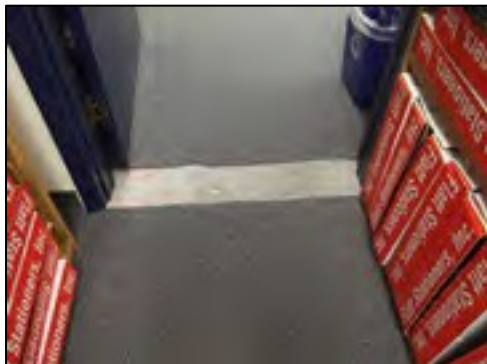
- Exposed concrete in doorway between rooms B102 and C101.

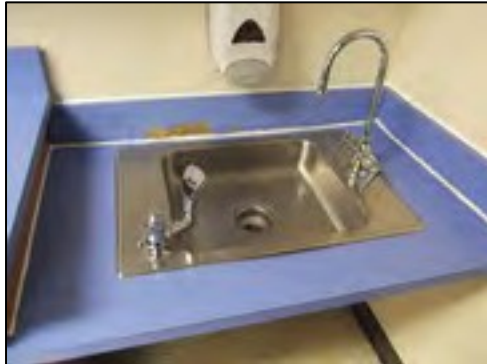
- Interior painted surfaces are in fair condition; interior surfaces should be repainted in the next 3 years.
- Backsplash and countertop damage at sink in room A113.

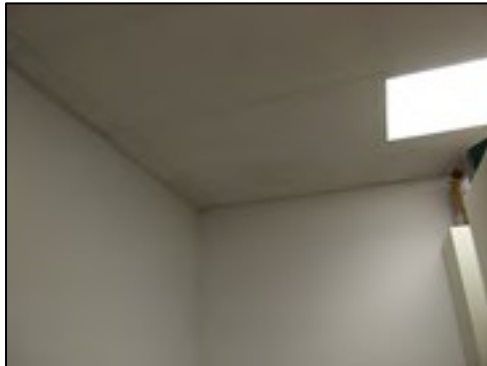
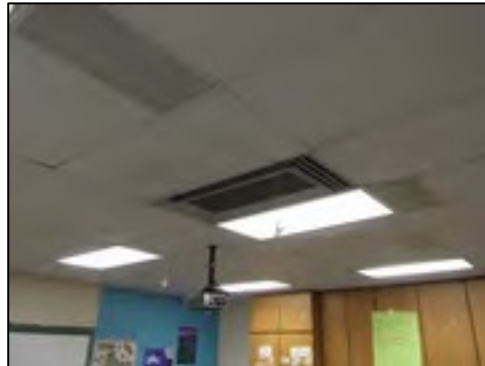
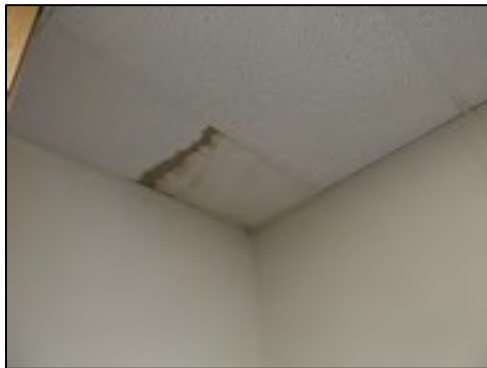
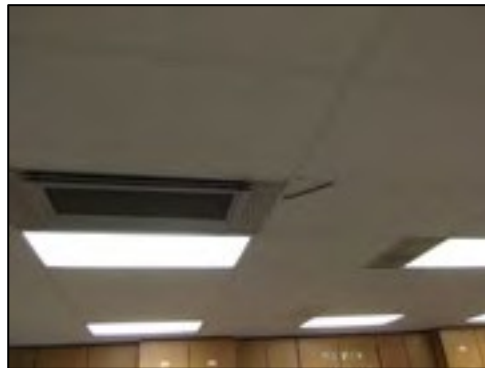
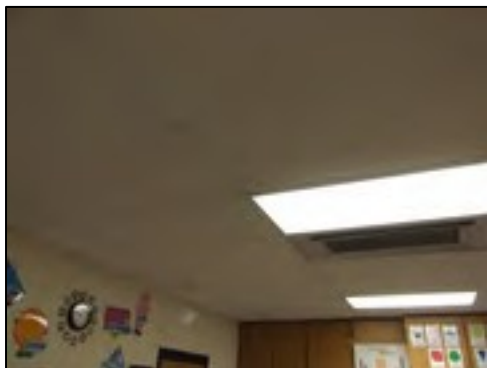
- Stained, sagging, and broken ceiling tiles observed in several locations.

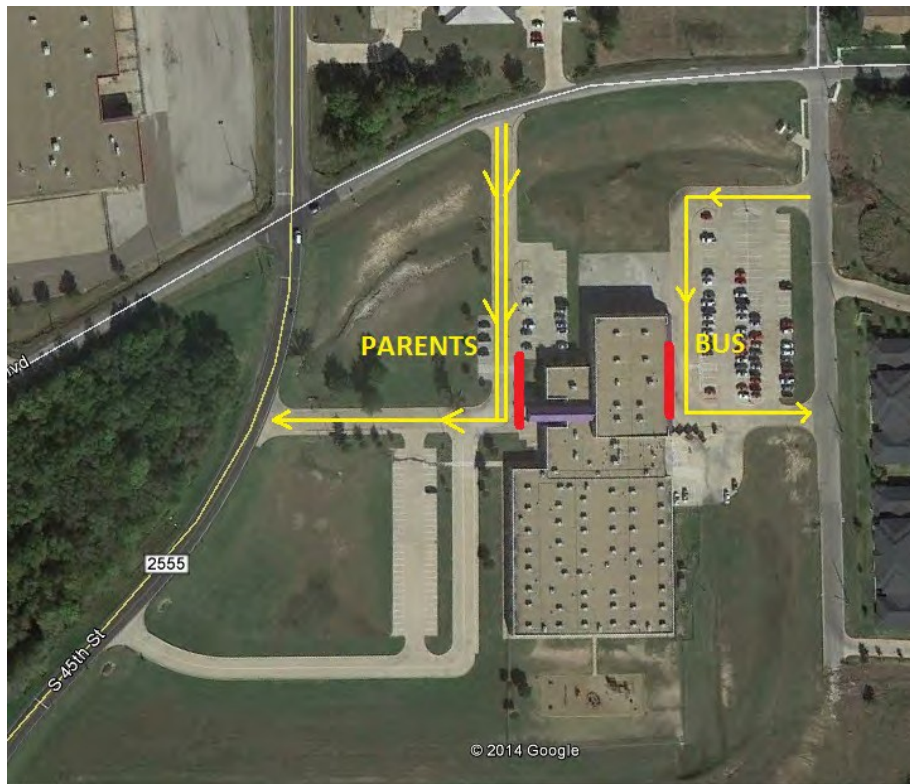
Student Loading Areas

- Parent loading for drop-off and pick-up on west side of campus backs up, especially during afternoon pick-up. There are two lanes of parent traffic at afternoon pick-up, with staff walking the students to cars. Afternoon parent and bus pick-up traffic takes approximately 10-15 minutes to disperse; parent vehicles have difficulty exiting the campus onto the west street due to traffic, causing congestion on the campus drives. Some parents circumvent the pick-up lines by parking in the lots, and crossing parent lanes to pick-up their children and walk them back; this creates additional safety hazards.

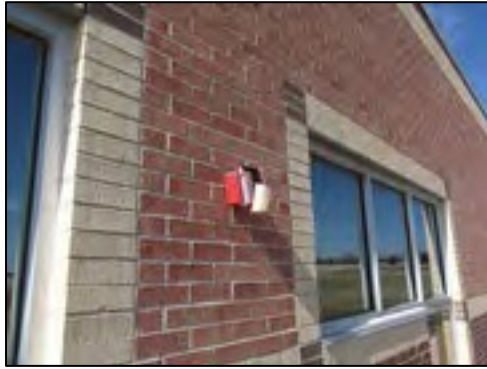
- Broken cover on exterior fire strobe.
