Collins Middle School

General comments, campus capacity, and student demographics:

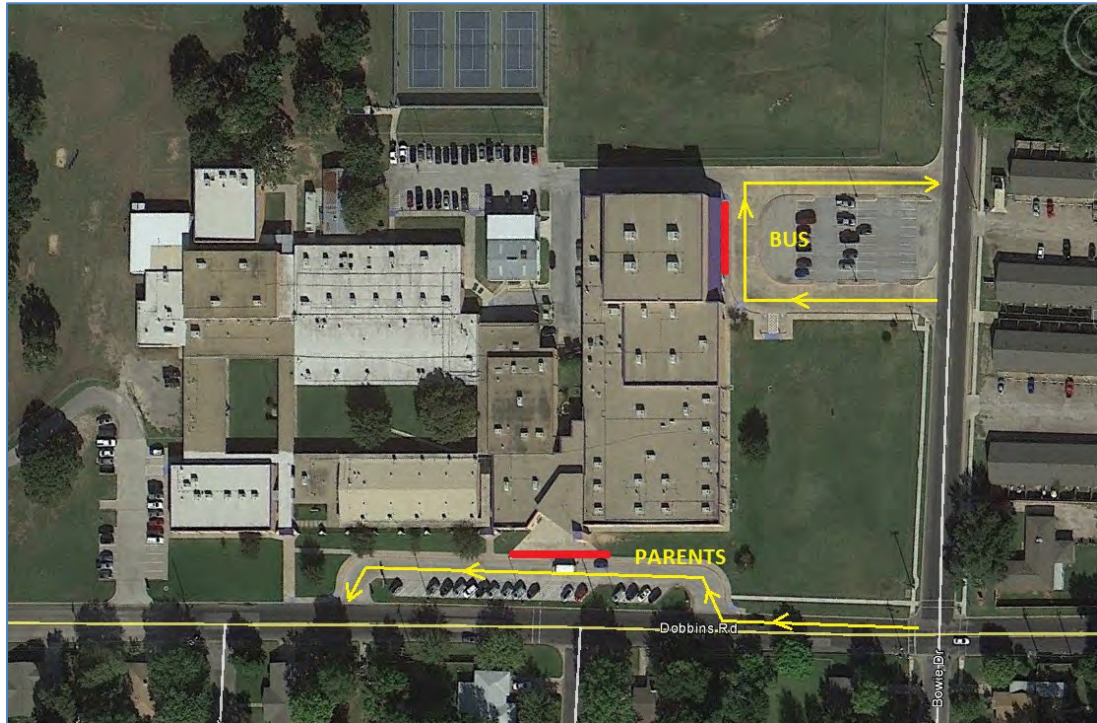
- Canopies should be provided at all student loading areas to provide protection from weather.
- Parent loading for drop-off and pick-up on south side of campus backs up, especially during afternoon pick-up. Afternoon parent and bus pick-up traffic takes approximately 10-15 minutes to disperse. Some parents circumvent the pick-up lines by parking on the streets, and crossing parent and bus lanes to pick-up their children and walk them back; this creates additional safety hazards.
- Parent traffic at afternoon pick-up.
